# Bridge Inspection Program

## FY 98 Routine Inspections

September 1998

New England District

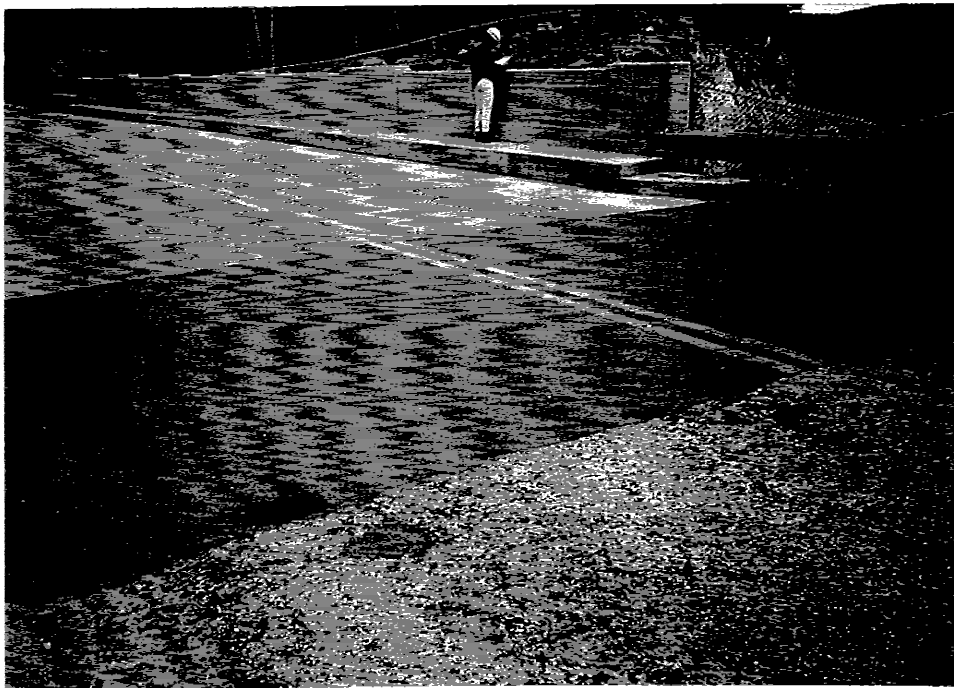
Photo 1: View of the south approach roadway.

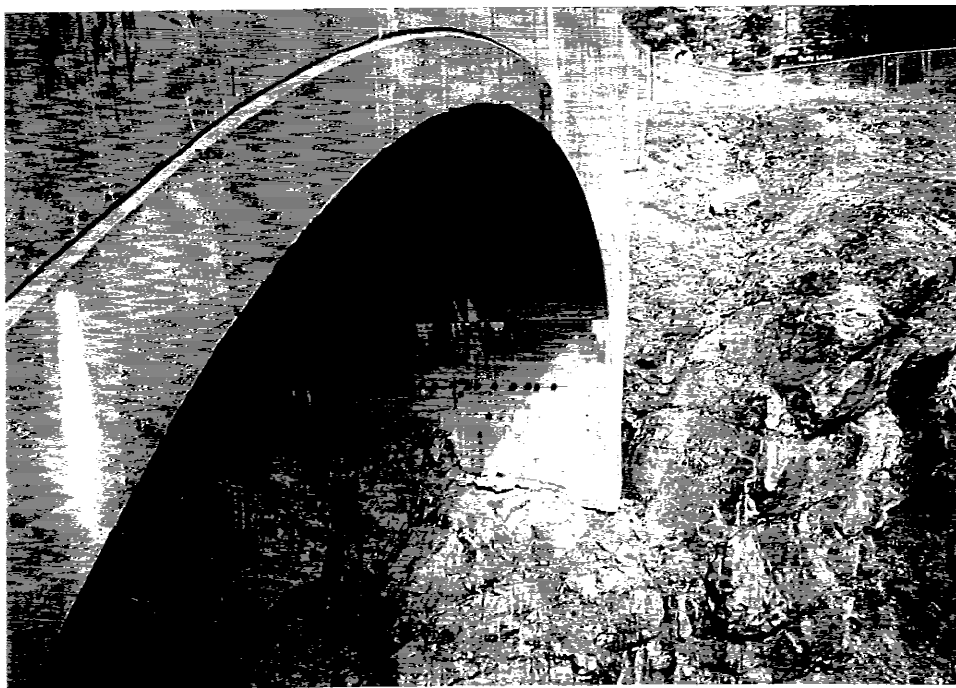
Minor abrasion and spalling were noted on the west and east fascias at the joint between the arch and the north abutment base. There is also moderate efflorescence leaching between the arch and the base joint at the north abutment face. Water draining off the road and down the northeast slope has caused undercutting of the arch base measuring 2'-0" long x 1'-4" deep x 7" high. Map cracking was noted at the west face of the south abutment base. There is also a 1/2" wide x 18" long x 1" deep crack present at the southwest base.

Photo 3: View of the north abutment. *Note the moderate efflorescence at the horizontal joint; the corroded drains; and the undercutting of the arch base at the northeast corner.*

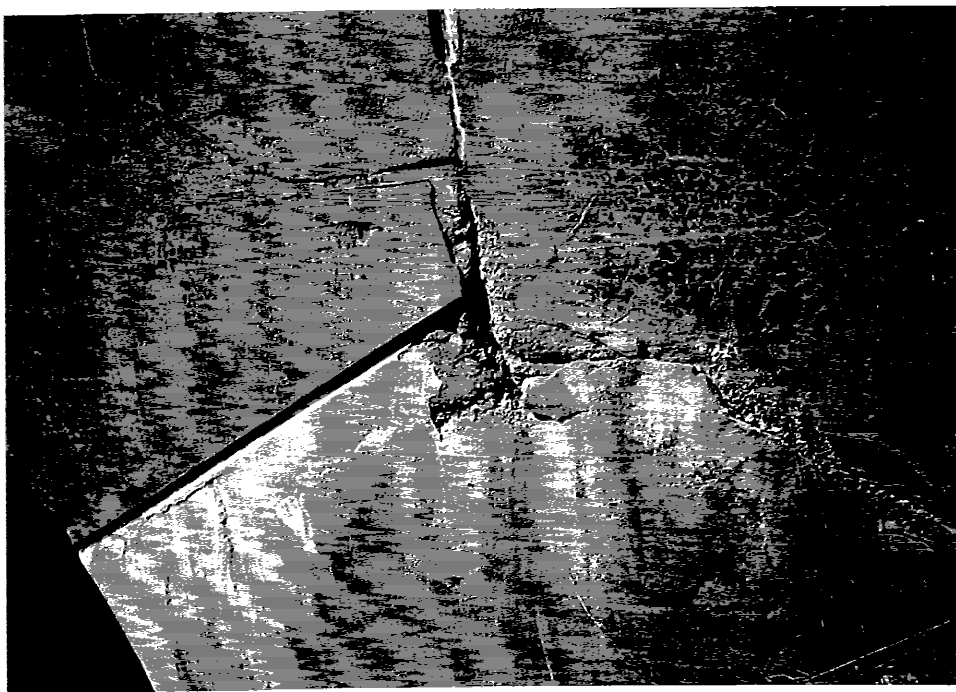
Photo 4: Concrete deterioration at the joint between the arch and the north abutment base. *Note also the efflorescence leaching at the joint.*

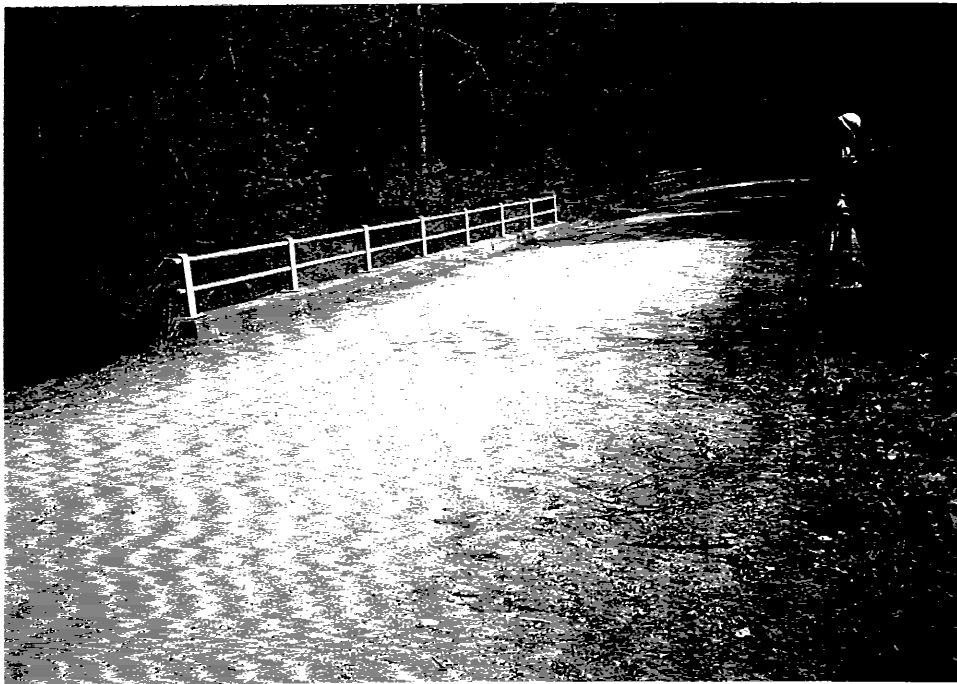
Photo 1: Pine Plains Bridge deck. *Note the lack of approach roadway guardrails, the debris at the edges of the bridge deck, and the good condition of the gravel wearing surface.*

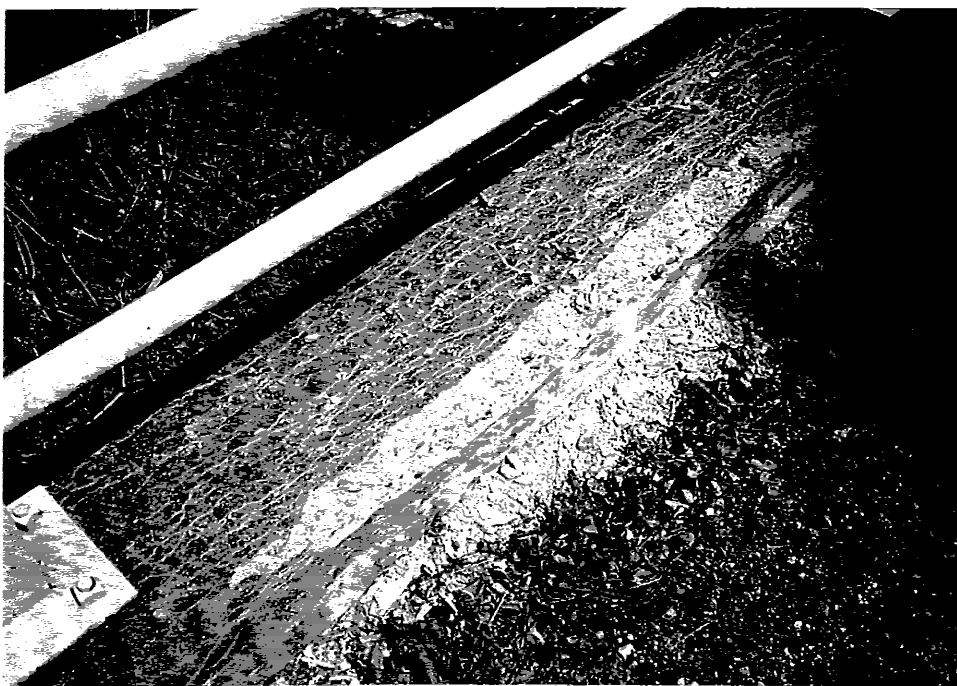
Photo 2: An area of concrete delamination at the south curb.

In addition to previous recommendations, repair all areas of concrete deterioration at both curbs, at the headwalls, and at the substructure.

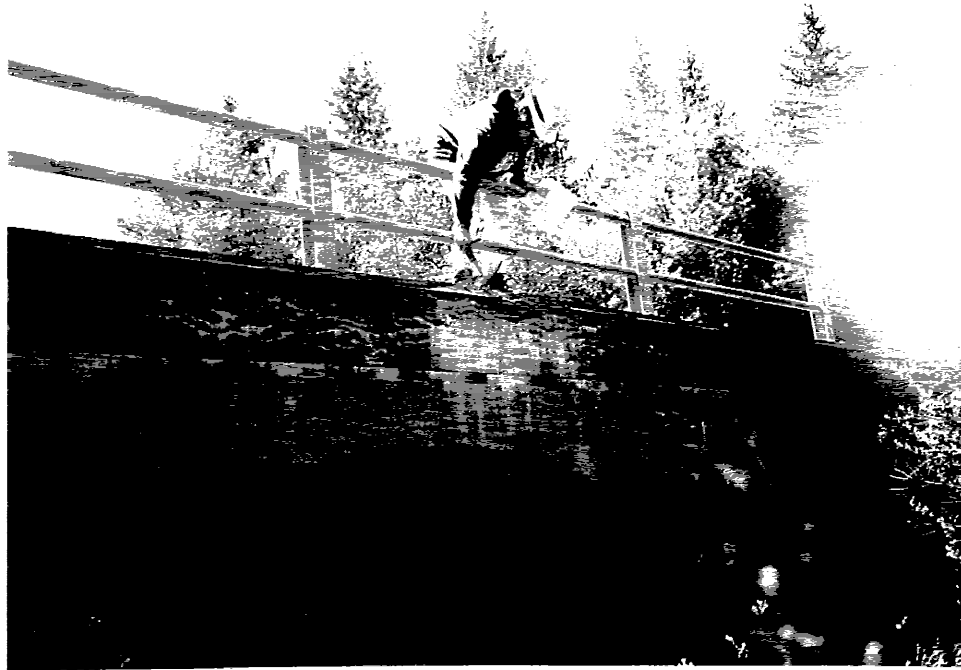
Both the metal plate arches are in good condition and show no signs of corrosion. Both the north and south headwalls of the west arch are delaminating and there are cracks with efflorescence at both headwalls. The north headwall of the east arch is experiencing map cracking with efflorescence at the entire area above and to the right (looking at the headwall) of the rim. No signs of deterioration are noted at the south headwall of the east arch.

Photo 3: The headwall above the west metal plate arch. Note the numerous cracks with efflorescence and most of the concrete of the headwall is unsound.

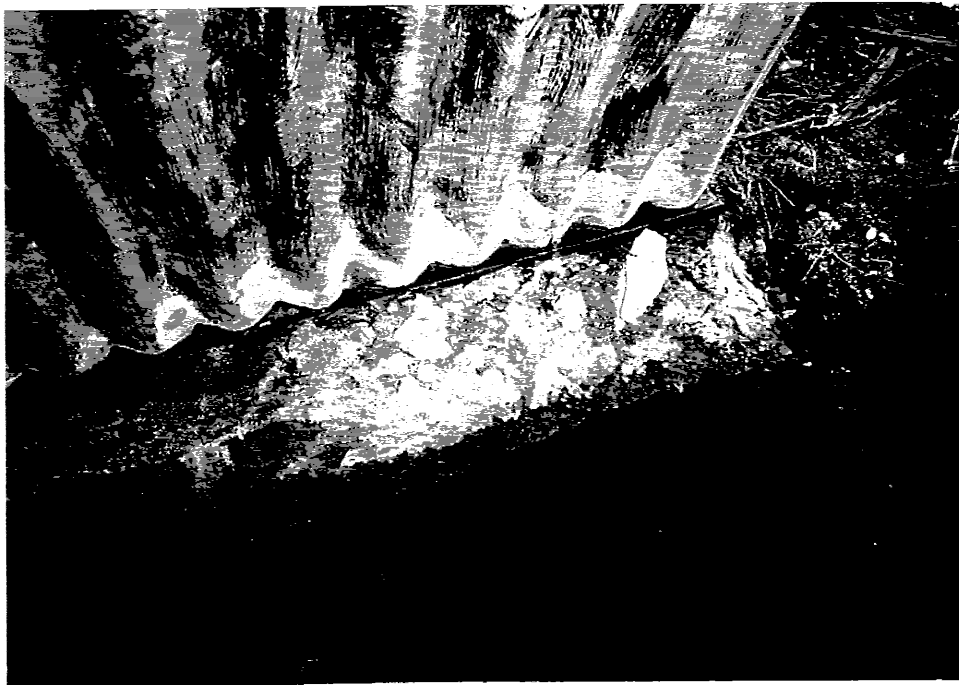
The footing of the west arch is being undercut at the west abutment at the north end due to upstream buildup diverting flow directly to this corner. The undermined area measures 3' x 1' x 1 1/2' deep. There is an approximately 10' length of spalled concrete at the pier of the east arch at the north end. At the south end of this same pier, there is a spall measuring 4' x 1'. The footing of the east arch at the east abutment at the north end is being undercut resulting in a spall measuring 2' x 1' x 8" deep. Towards the south end of this abutment, there is abrasion

Photo 4: A spall, measuring 3' x 1' x 1 1/2', at the footing of the west arch located at the north end of the west abutment.

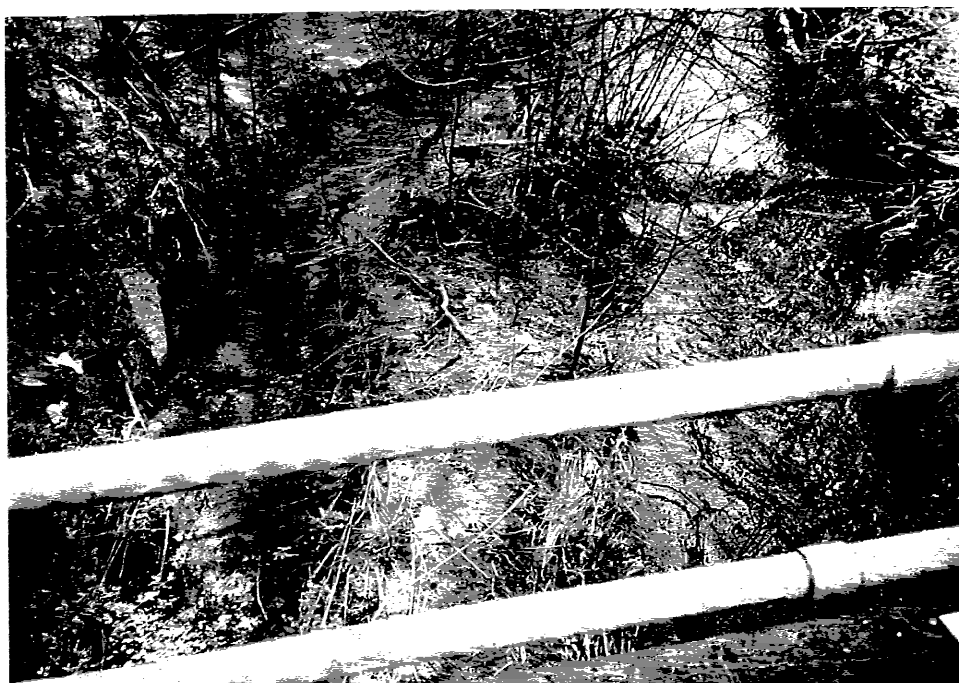
Photo 6: Upstream view of the channel. Note the silt buildup in the middle, diverting the flow of the channel.

Restore the channel profile to its original configuration by removing all broken tree branches, deposited silt, and vegetation overgrowth.

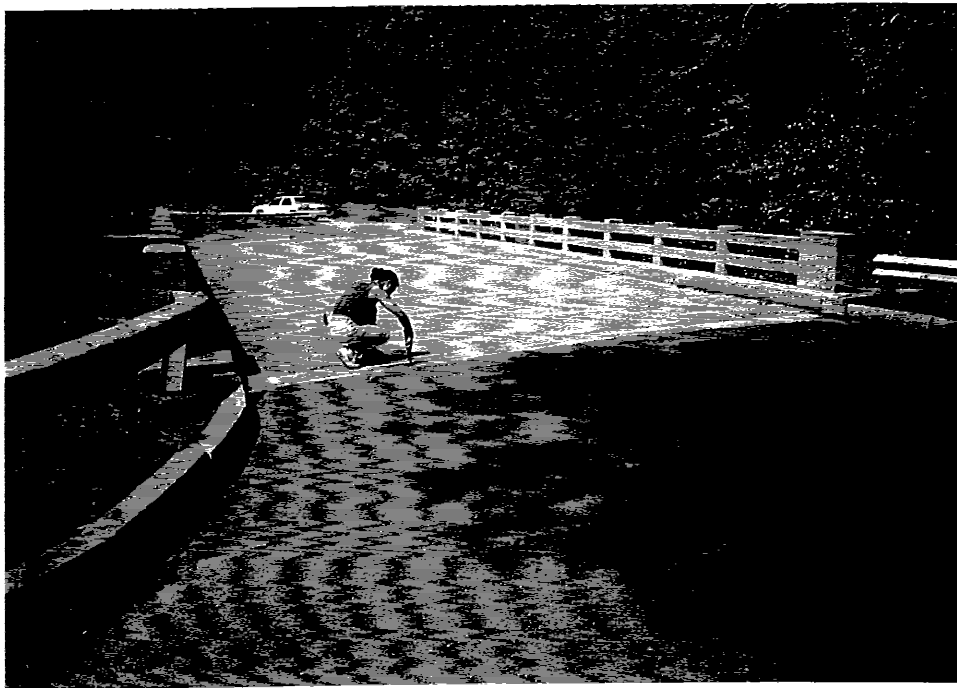
Photo 1: East approach roadway. Note the rust spots on the approach guardrail; the good condition of the expansion joint plate; and the good condition of the bridge deck.

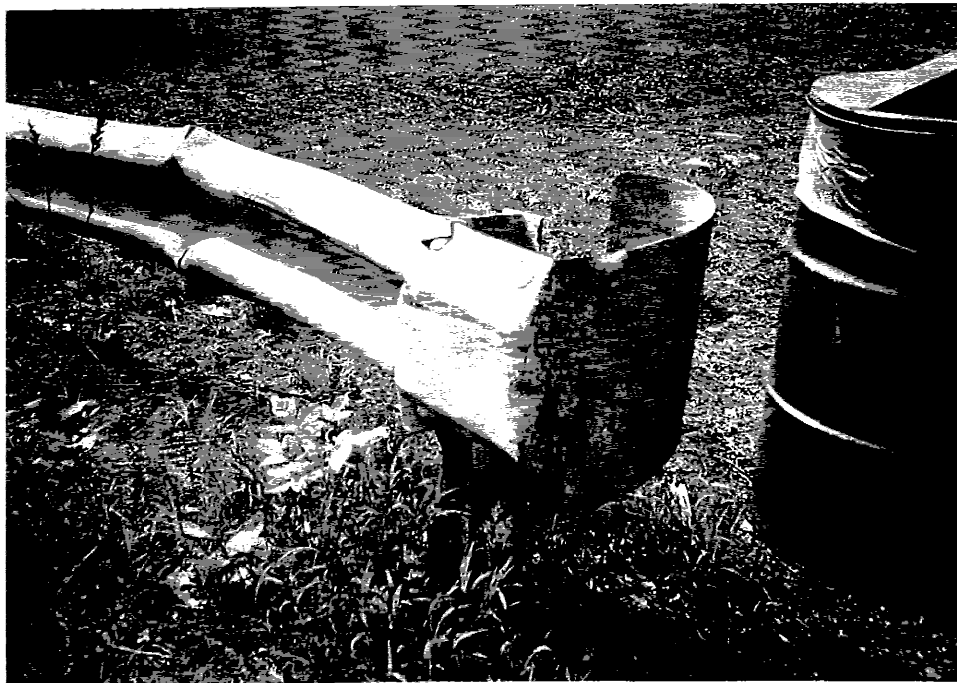
Photo 2: The damaged westernmost rail of the west approach guardrail. Note the rust stains of the rail and post.

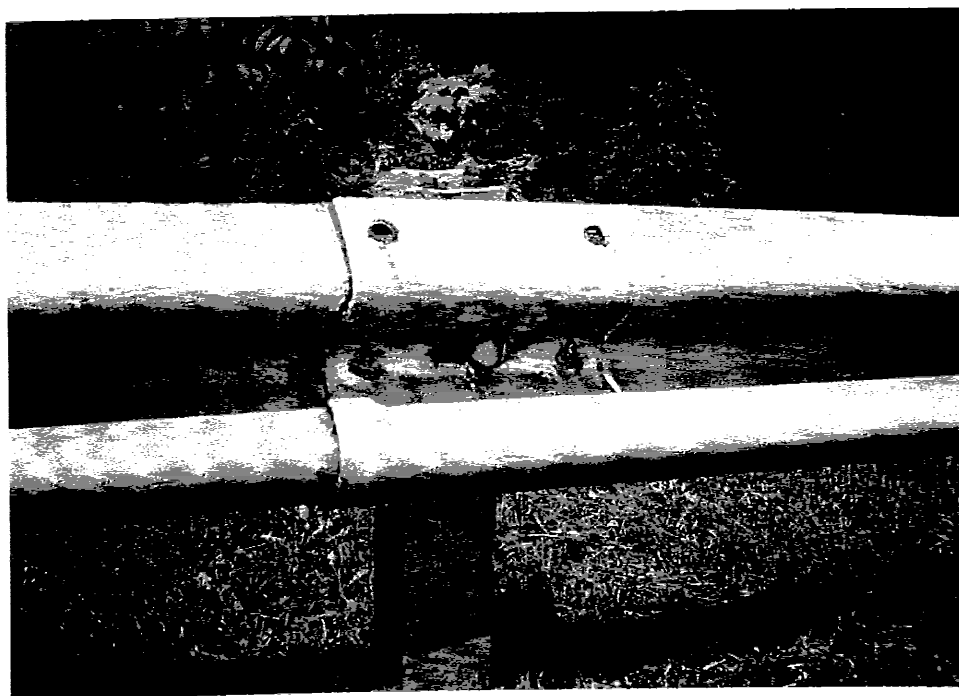
Photo 2: Missing bolts at the approach guardrail.

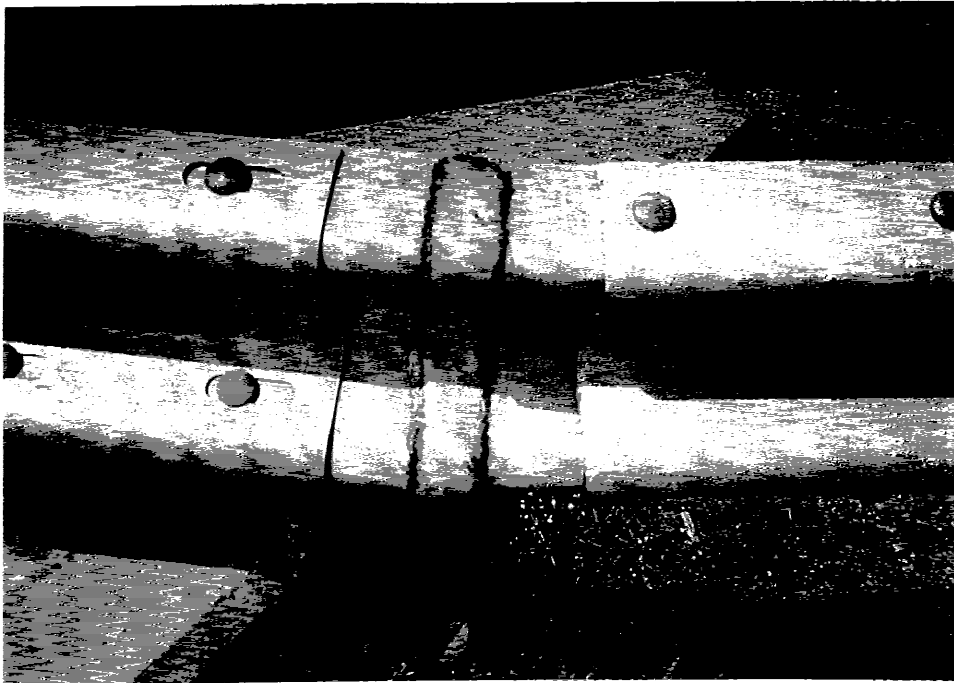
Photo 3: New section of transition guardrail installed and bolted to the approach guardrail. *Note the tack welded piece is bolted at both ends to allow for movement.*

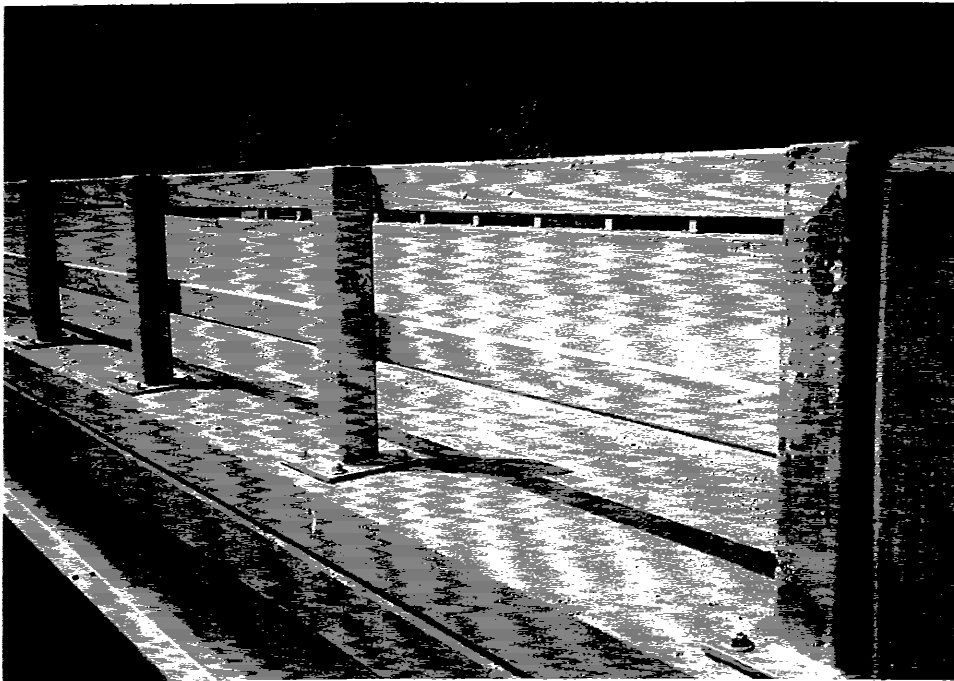
Photo 4: Hairline cracks with efflorescence on the outside face of the curb at the guardrail post locations. *Note the paint system peeling at the bridge deck guardrails.*

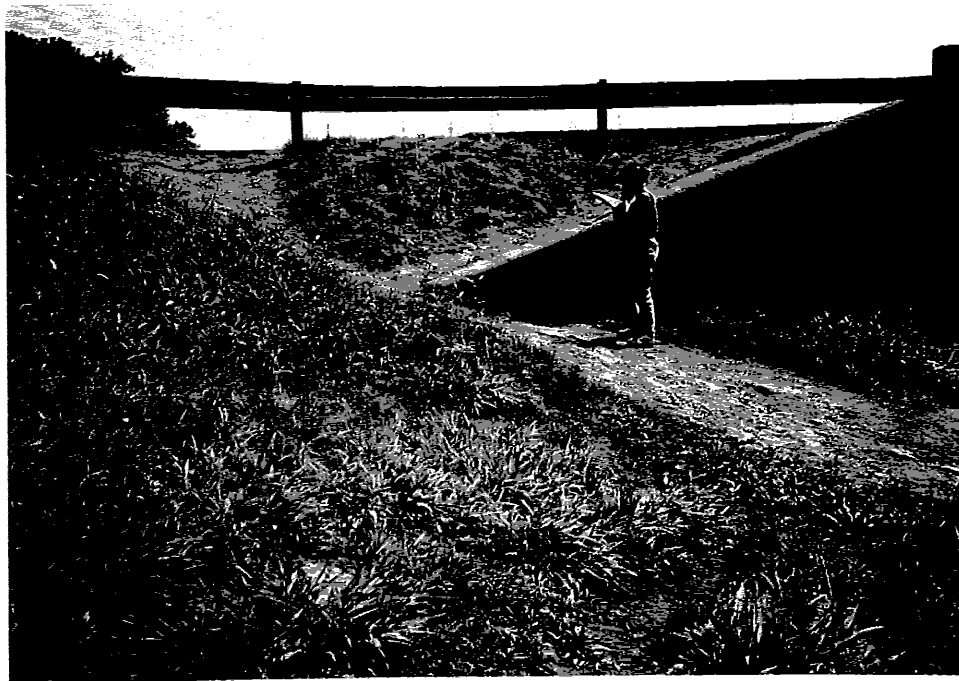
Photo 6: Erosion behind the southwest wingwall due to drainage from the road.

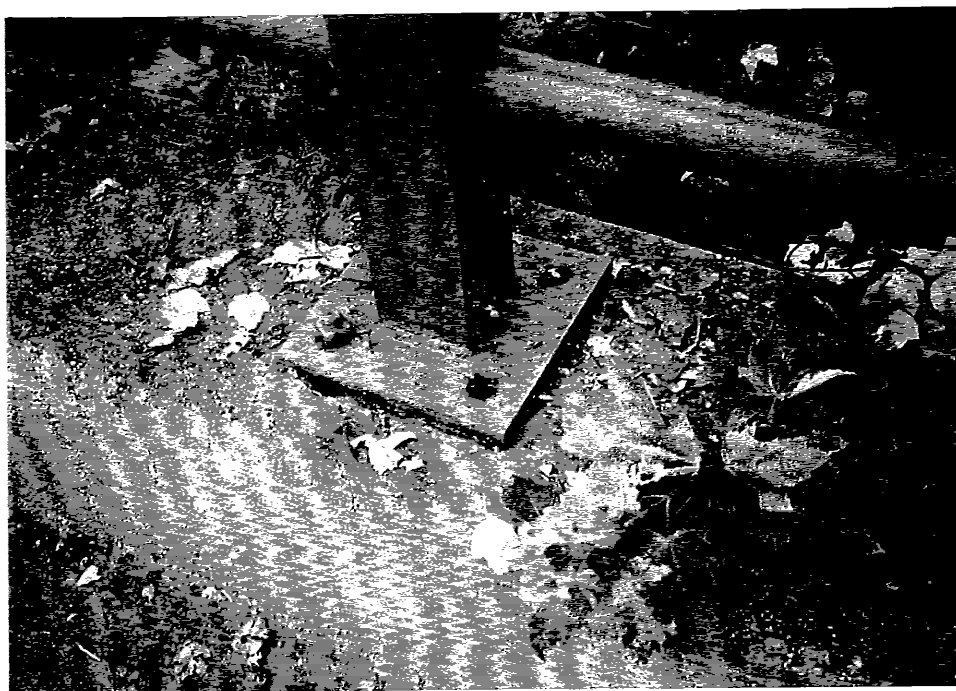
Photo 2: Missing anchor bolts at the south guardrail base plate.

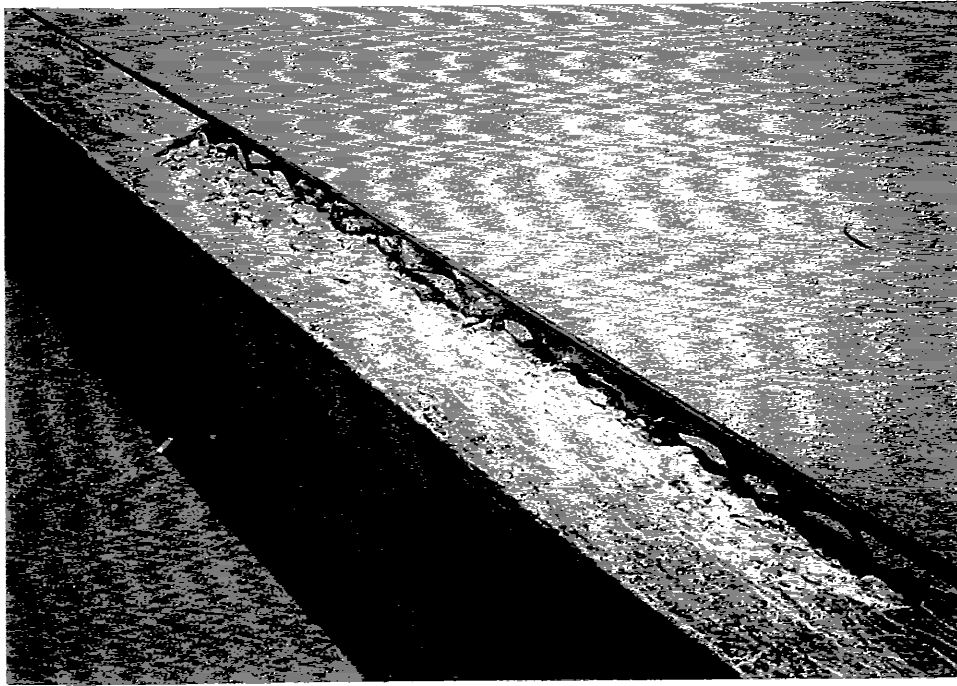
Photo 1: Deterioration (2' x 6" x 3" deep) and delamination (10' x 9") of the north sidewalk curb. *Note the corrosion of the steel curb edge.*

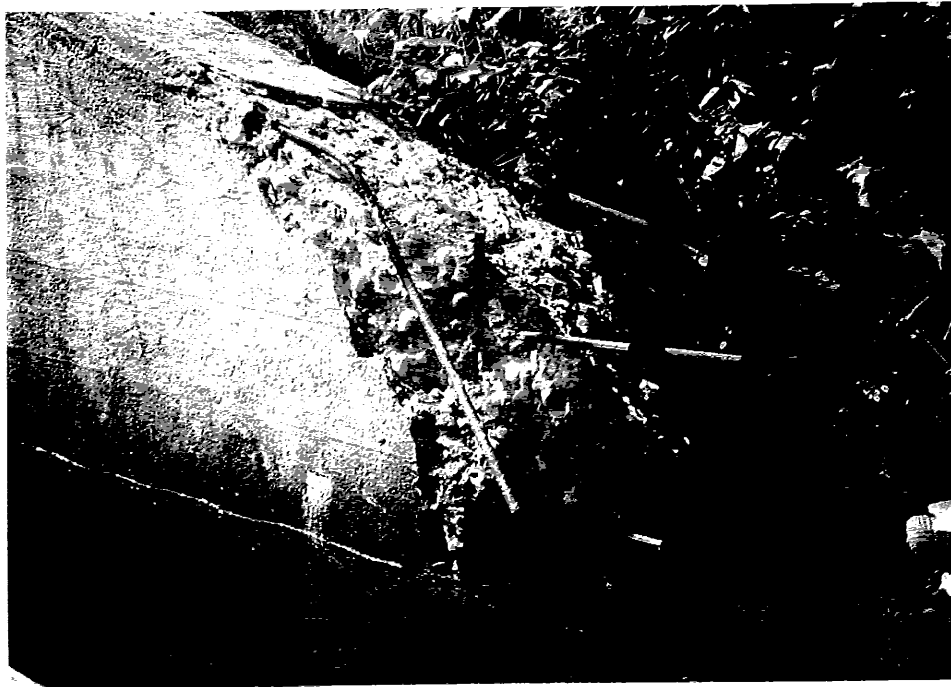
Photo 5: A 3' long, 15" wide section of the northwest wingwall is deteriorated down to the channel bottom. *Note the sections of exposed rebar at the spalled area.*

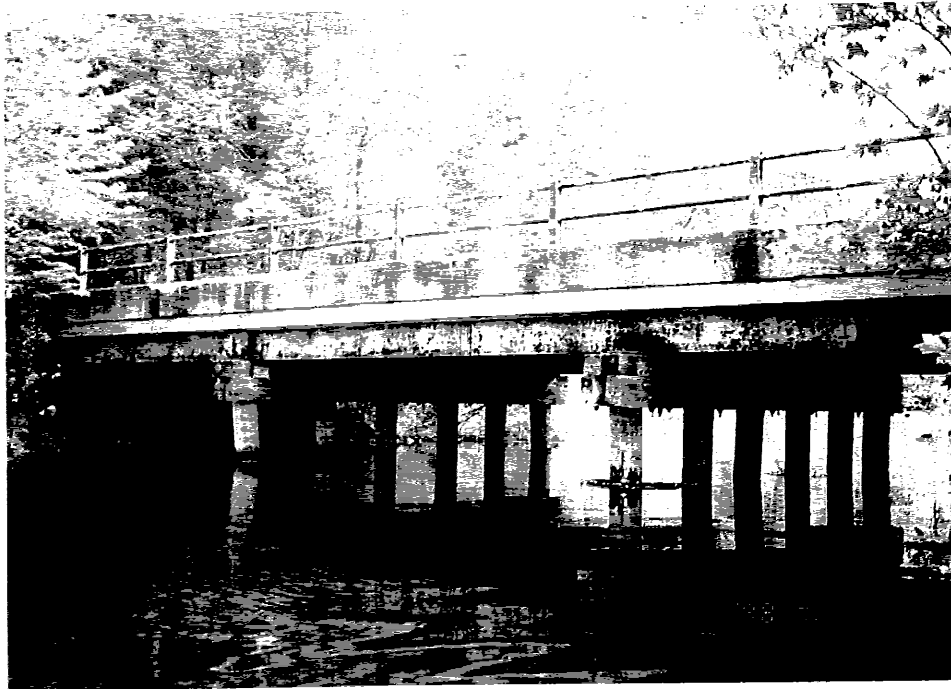
Photo 1: South elevation of Old Morse Road Bridge. Note the moderate rusting of the guardrails, the extensive spalling of the parapet, and the moderate surface corrosion of the steel beams.

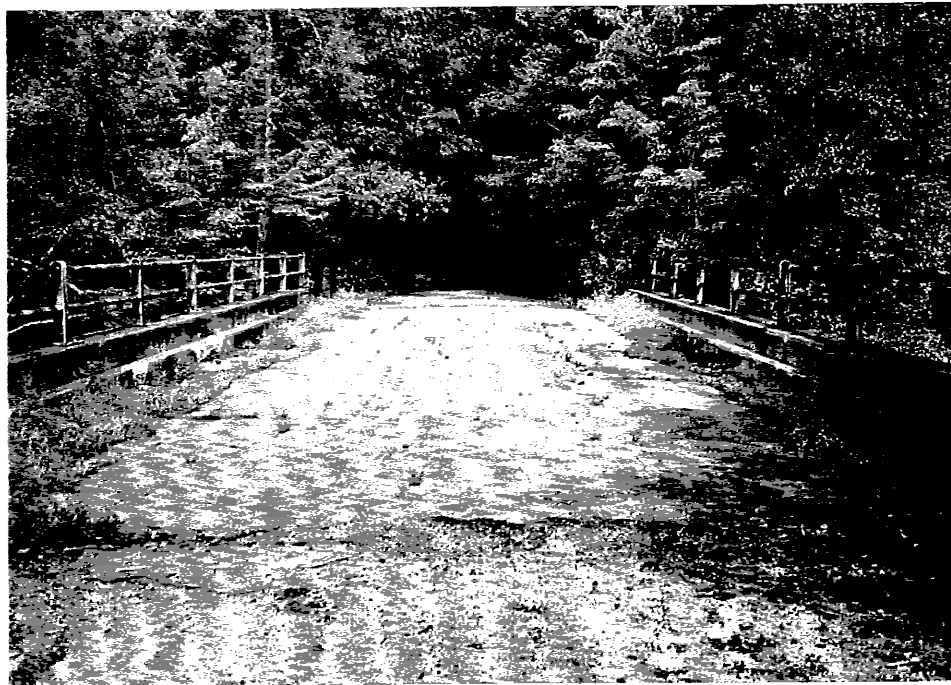
Photo 2: The bridge deck and the east approach roadway. Note the missing sections of the bituminous approach paving and the heavy vegetation at the edges of the deck

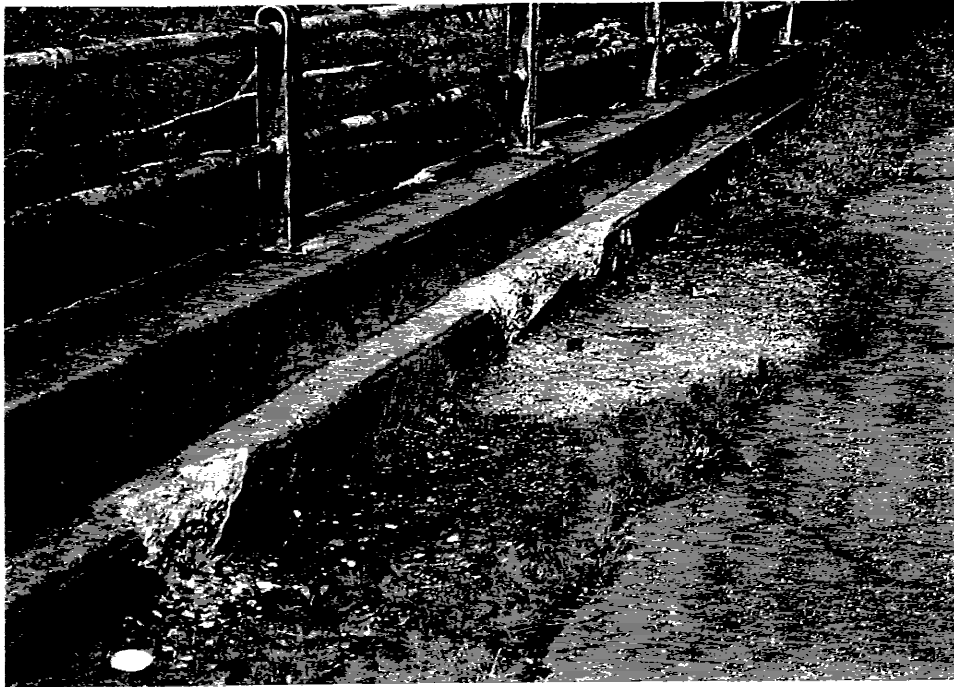
Photo 3: Extensive spalling of the south curb and parapet. Note also the missing bituminous paving and the heavy vegetation.

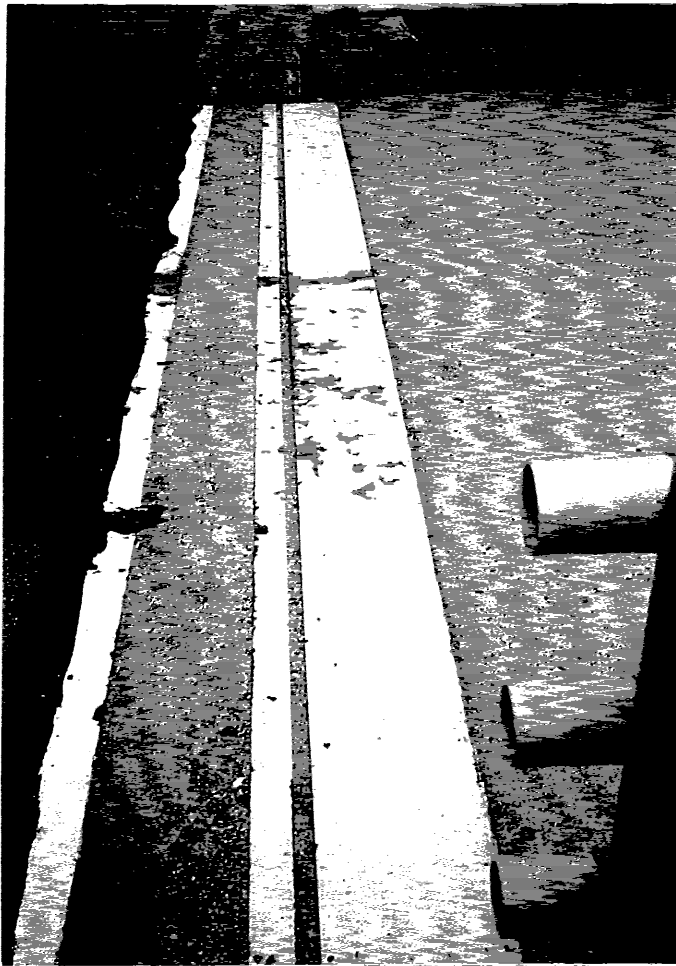
Photo 1: Areas of deteriorated concrete at the east abutment backwall. *Note: the missing paint at the deck joint.*

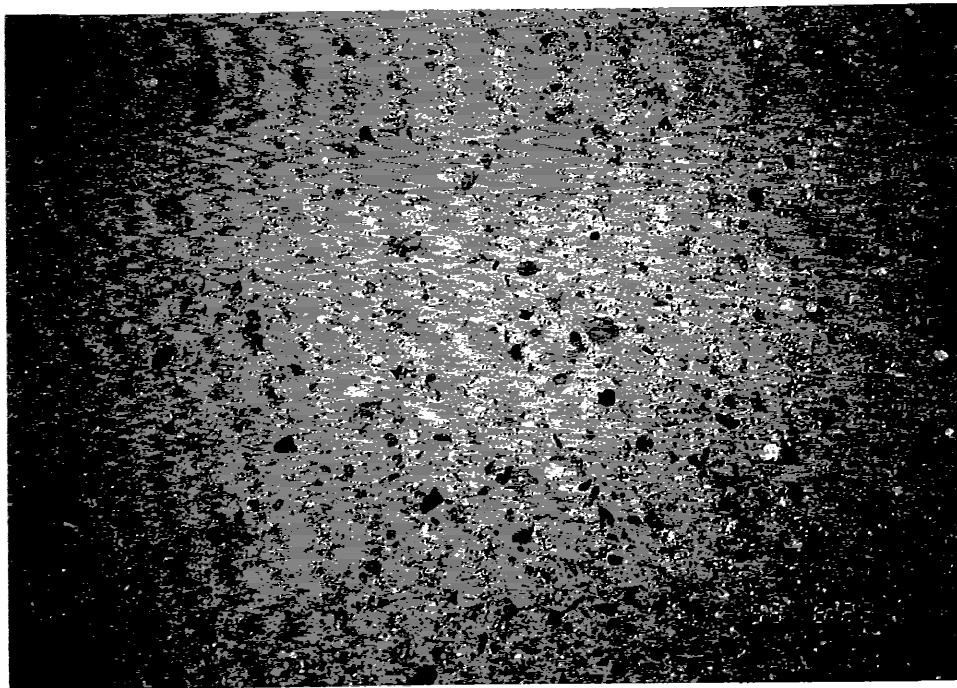
Photo 2: Moderate abrasion of the bridge deck surface. *Note: several concrete patches on the deck.*

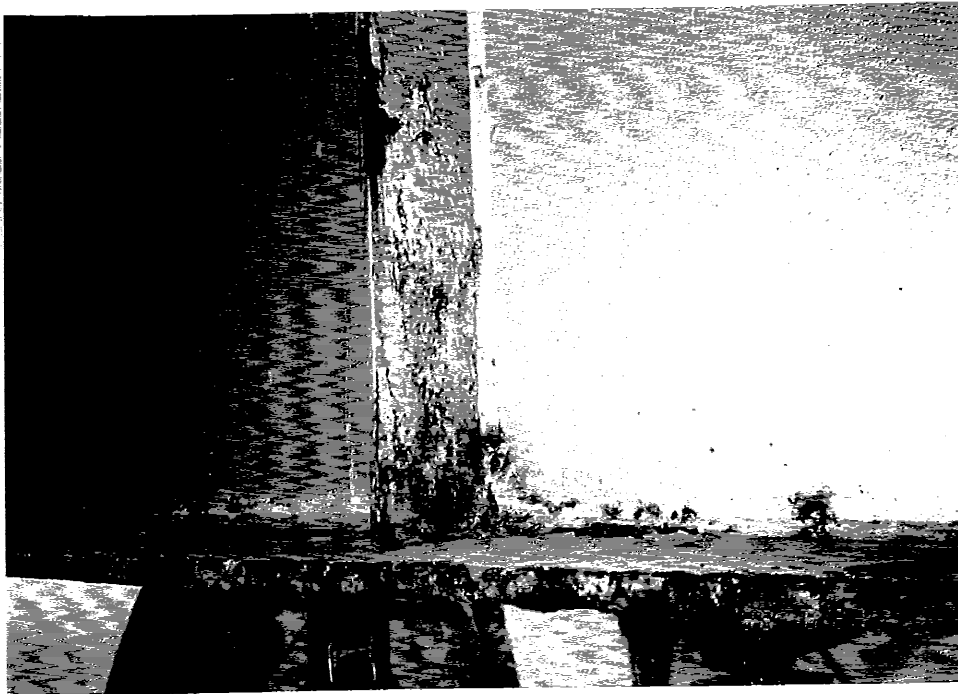
Photo 3: Typical moderate to severe corrosion and section loss of the bottom flange of girder 1 at the first three sections (between diaphragms) adjacent to the bridge seat.

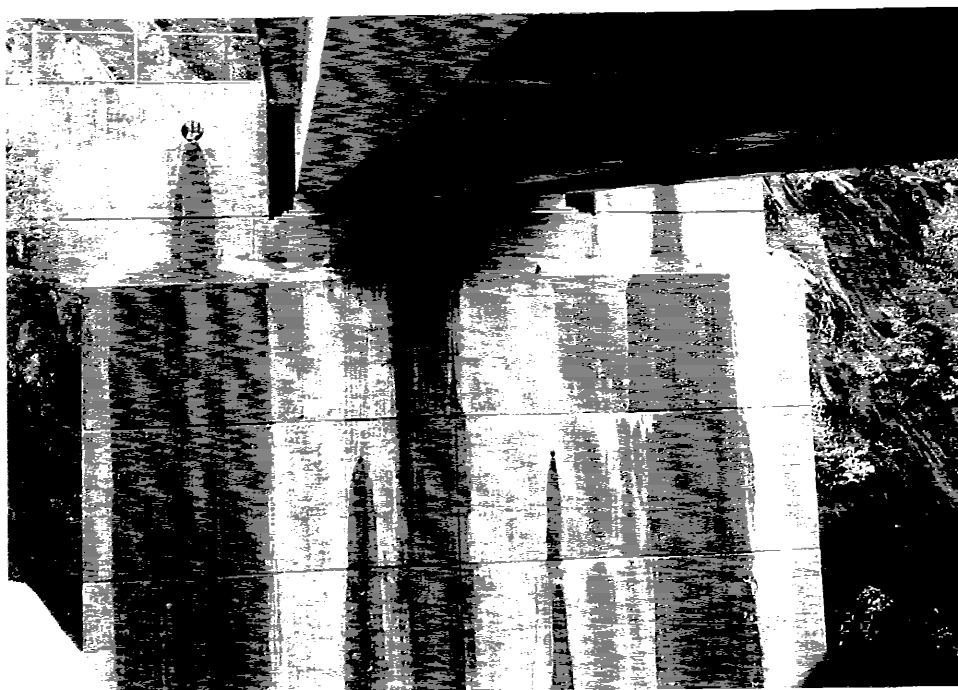
Photo 5: Elevation of the east abutment. *Note: the seepage from the drains on either side of the bridge and the PVC drain.*

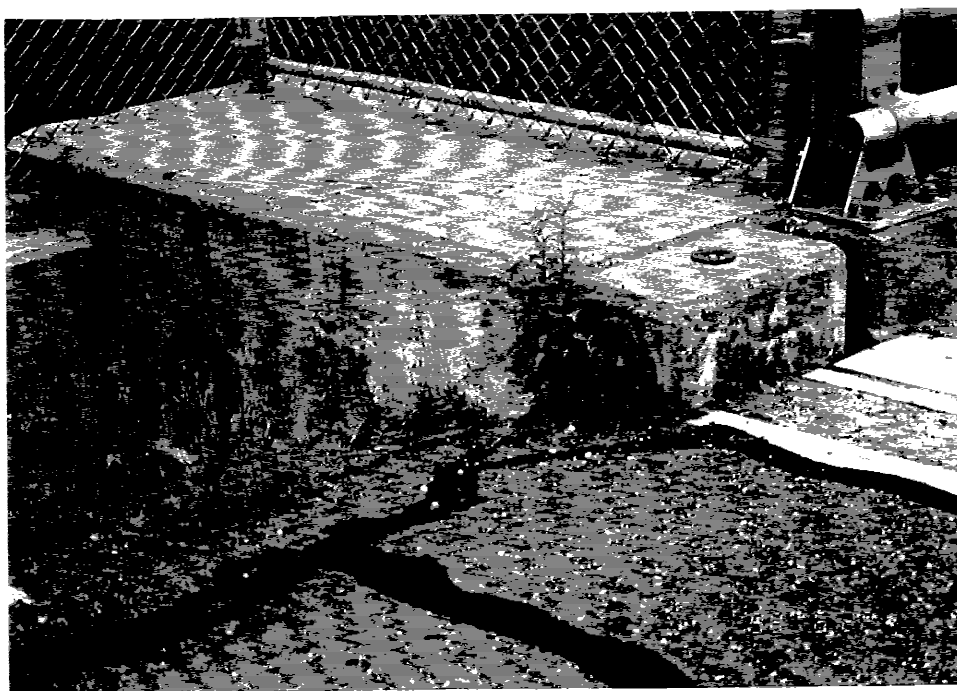
Photo 6: Cracks with efflorescence on the backside of the exposed south backwall adjacent to the drain and the east approach.

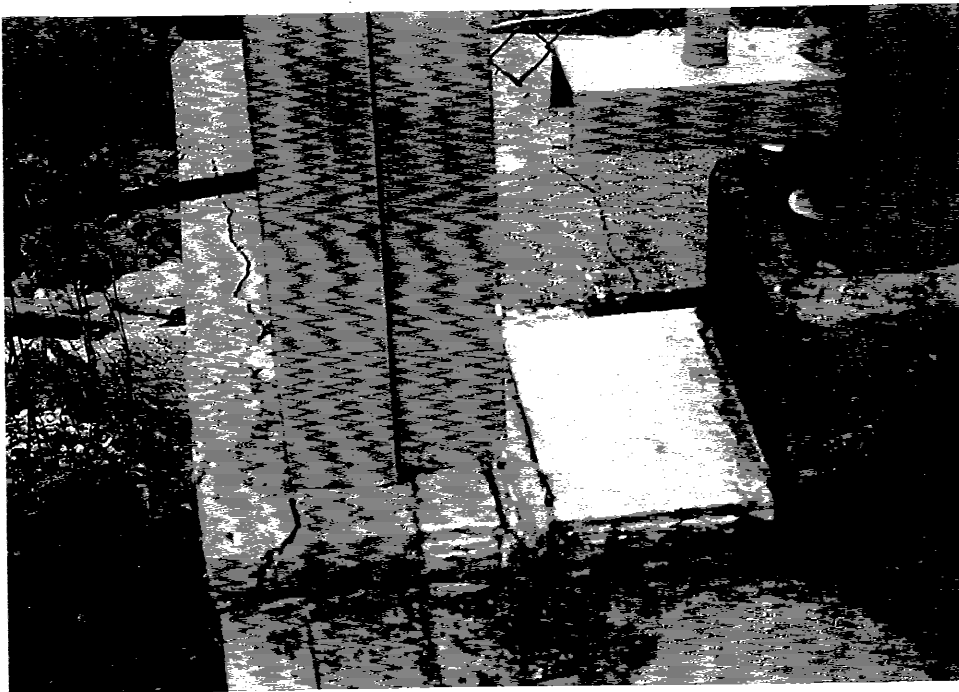
Photo 4: A  $\frac{5}{8}$ " crack at the south end of the east abutment backwall where the guardrail and the fenceposts are located and also a hairline crack located 2" from the backwall

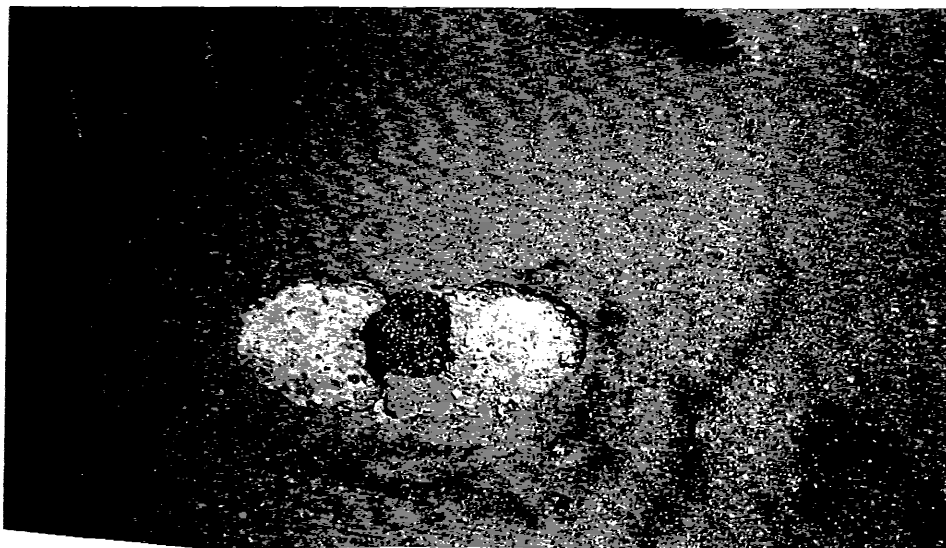
Photo 3 - Worst area of deteriorated and unsound area of concrete near center of deck (Below)

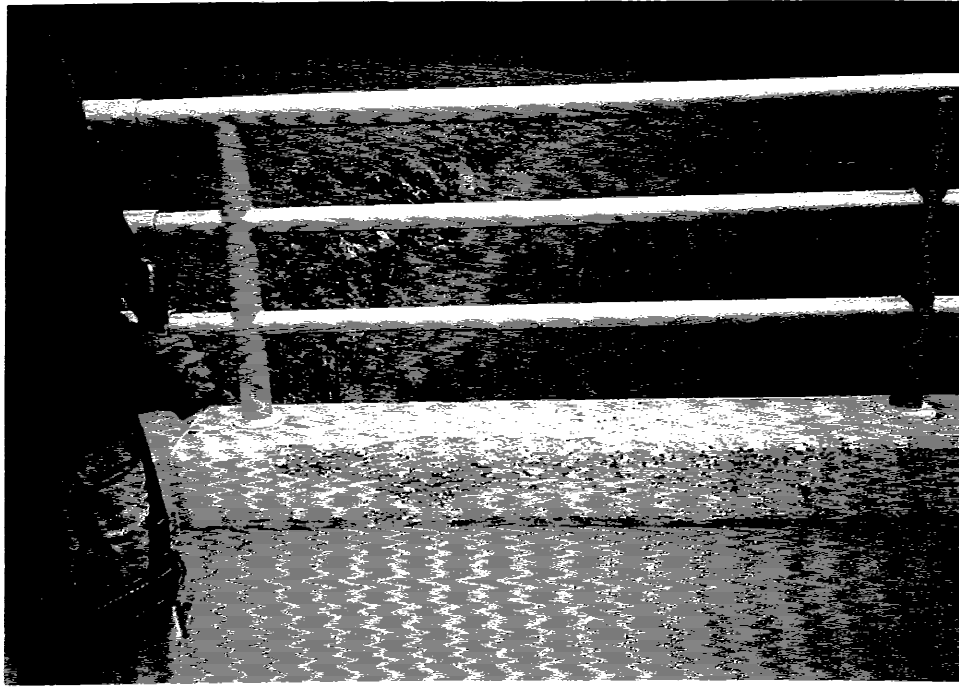
PHOTO NO. 3 Concrete Spall at the curb along the North side

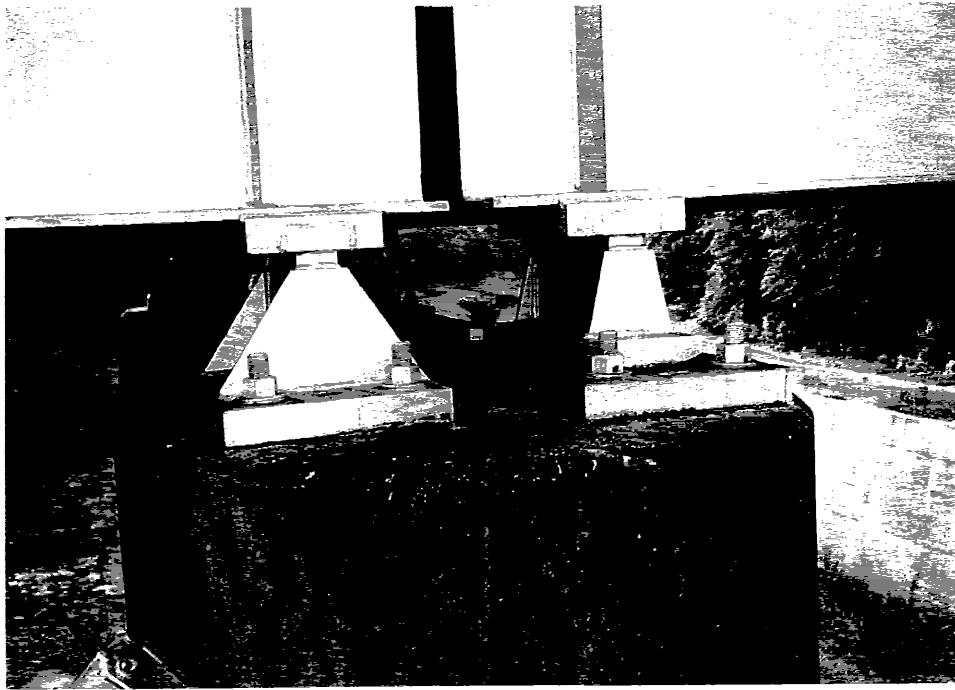
PHOTO 1. THE CENTER PIER OF THE DOWNSTREAM BASE HAS MINOR HAIRLINE CRACKS WITH EFFLORESCENCE.

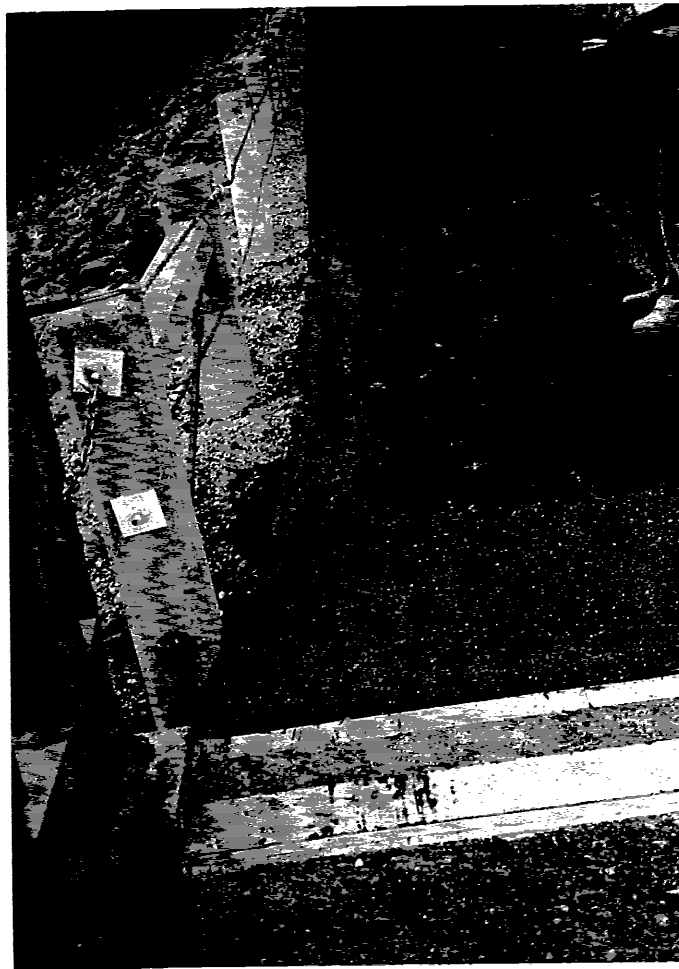
PHOTO 2. SEPARATION OF BITUMINOUS PAVEMENT AT SOUTH EAST GUARD RAIL

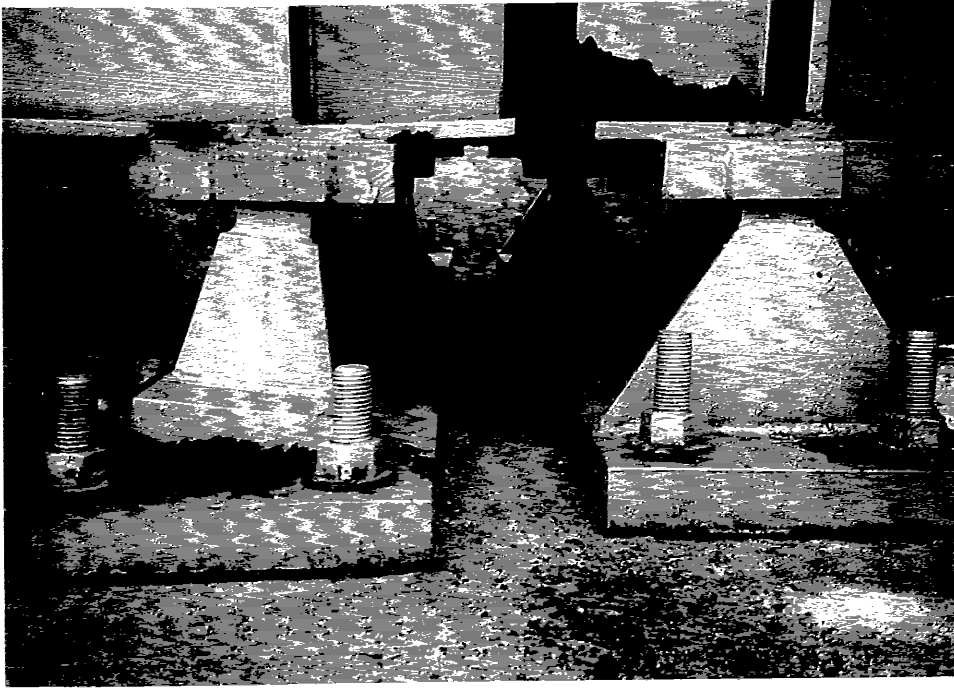
PHOTO NO. 1 Rusting on expansion rocker (left) and both bearing plates

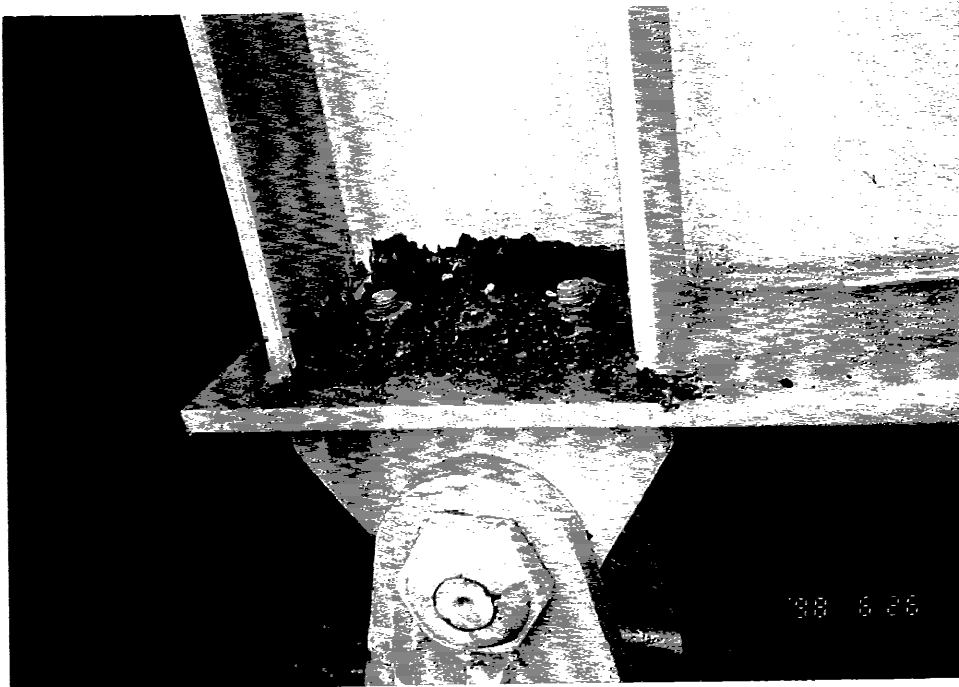
PHOTO NO. 2 Couple of the bolts rusting through on the top of the bridge seats.

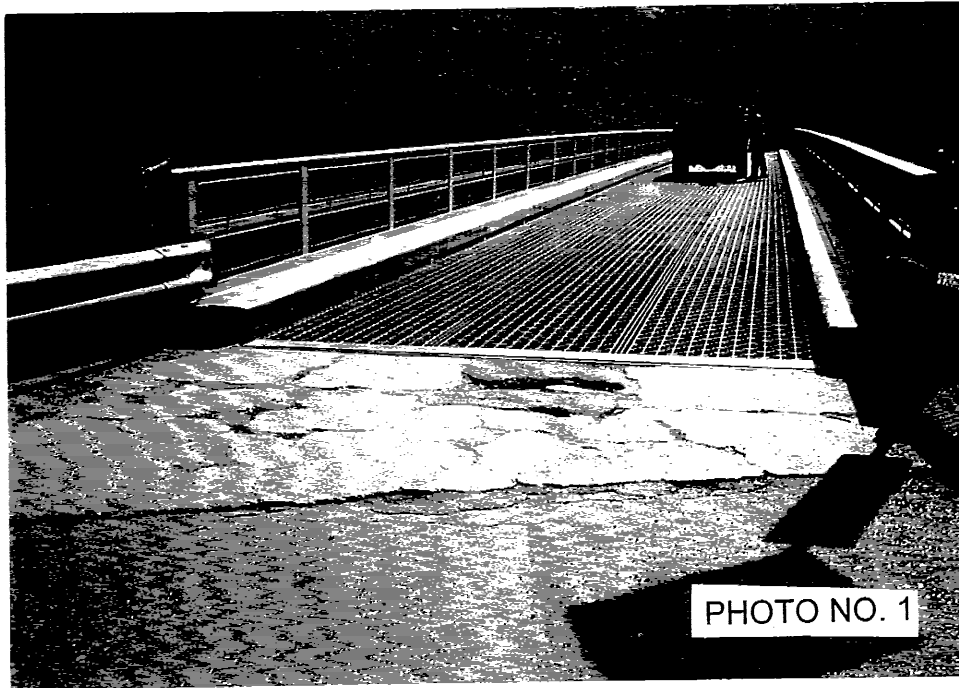
Photo 1 - East Approach; Note extensive deterioration of approach slab.
